Manhole Inspection Summary

Manhole # **S15C__040MH**

Insp Date: **11/29/07 1:50 PM**

Location Address: **REAR 2544 WHITMORE**

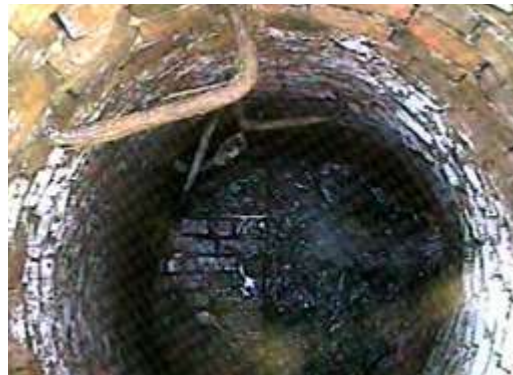
Defect 1

Condition: ☐ Sound ☐ Cracked ☐ Root Intrusion ☐ Loose Brick ☒ **Deteriorated**

Count: **3** Missing: **0** ☒ **Corroded**

☒ **Evidence Of Surcharge** Depth: **3** (ft.) ☐ Active Surcharge Present

deteriorated corbel; corroded steps;
evidence surcharge

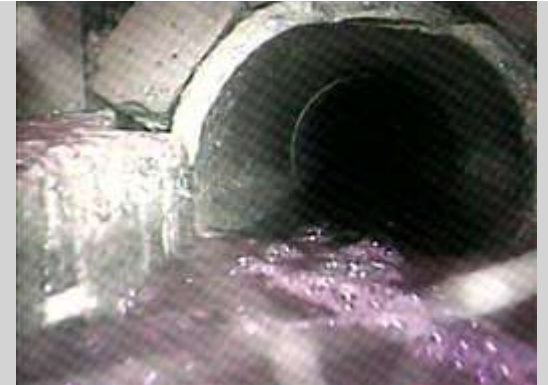
12 O'Clock Outflow

Pipe Height: (in.) Direct
Pipe Material: **Clay** ☐ Pipe Lined
Invert Depth: **8.00** (ft.) Flow Characteristics: **Slow**
Deposits: ☒ None ☐ Mud ☐ Sludge ☐ Debris ☐ Grease
Silt Depth: (in.) Deposits Extent:
Infiltration: **None** Pipe Seal Cond: **Sound**

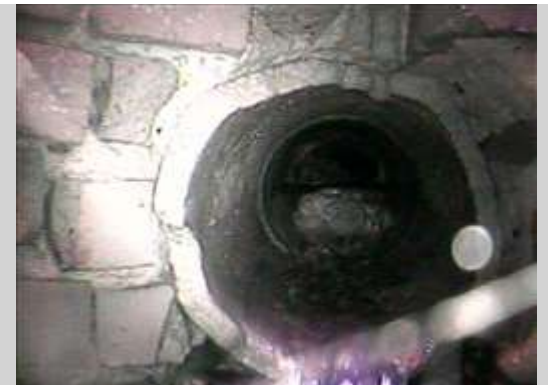
3 O'Clock Inflow

Pipe Height: (in.) Direct
Pipe Material: **Clay** ☐ Pipe Lined
Invert Depth: **6.45** (ft.) Flow Characteristics: **Slow**
Deposits: ☐ None ☐ Mud ☒ Sludge ☒ Debris ☒ Grease
Silt Depth: **8** (in.) Deposits Extent: **Heavy**
Infiltration: **None** Pipe Seal Cond: **Broken**

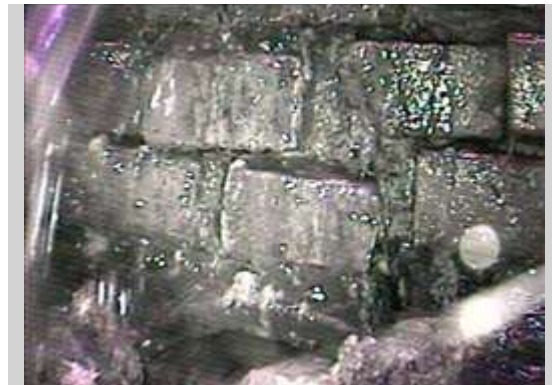
Drop In @ 3 O'Clock

Drop: **Outside Direct**
Angled: Reading: (ft.)
Inv Depth: **8.06** (ft.)

Drop Condition: **Clogged**

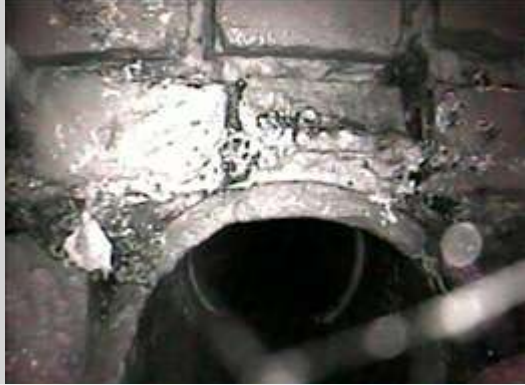
6 O'Clock Inflow

Infiltration: **None** Pipe Seal Cond: **Sound**
